# **Electrical Installation Revitalization at Holland Spot Café in Tahura Bandung**

**HENDY EKA PRATAMA, NUGRAHA DWI PUTRA, NURDIANSYAH,  
RUSTAMAJI<sup>1</sup>, KANIA SAWITRI<sup>1</sup>**

Program Studi Teknik Elektro Institut Teknologi Nasional Bandung

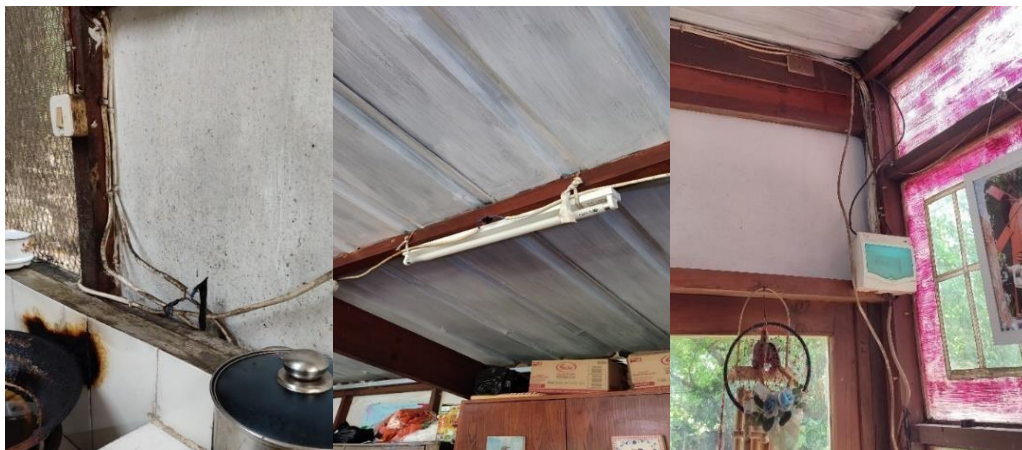
**Figure 2. Existing Electrical Installation Conditions Before Revitalization**

The initial site survey identified several electrical installation deficiencies that posed potential safety hazards. As shown in Figure 2, the existing lighting installation exhibited deteriorated electrical components, exposed wiring, and improperly mounted fluorescent light fixtures. These conditions indicated that the installation did not comply with the requirements of PUIL 2011 and required immediate corrective action to improve both electrical safety and operational reliability.

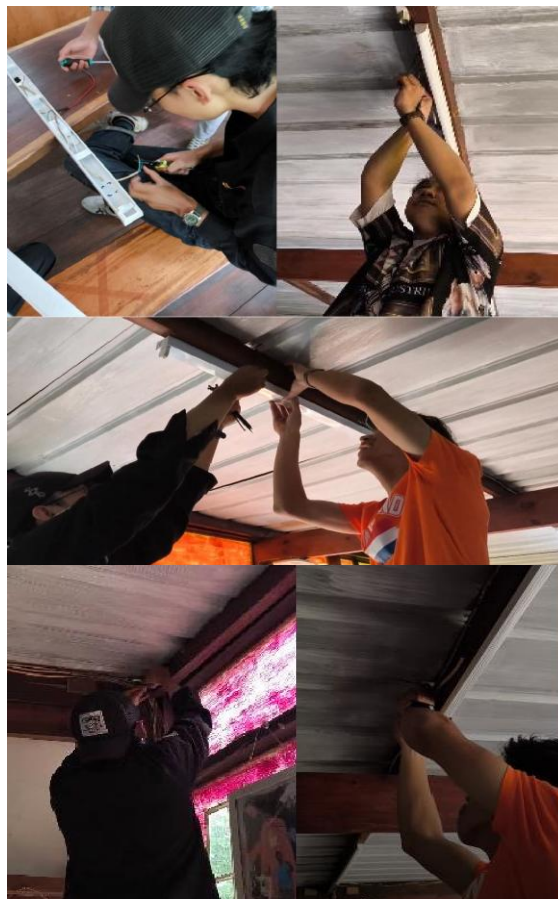
**Figure 3. Repairing The Installation**

The revitalization of the electrical installation at Café Holland Spot Tahura was executed from October 10 to December 20, 2024. The primary goal was to resolve severe technical deficiencies identified during initial inspections and align the infrastructure with PUIL 2011 safety standards. The active execution phase of the technical repairs is shown in Figure 3.

As illustrated in Figure 3, the technical team addressed three core physical defects:

- **Cable Replacement and Sizing:** Outdated, single-insulated cables were replaced with high-quality NYM cables featuring double-layer insulation to protect against mechanical wear and current leakage. To support safe Current Carrying Capacity (KHA), circuits were segmented using 2.5 mm<sup>2</sup> conductors for commercial power outlets and 1.5 mm<sup>2</sup> conductors for lighting paths.
- **Connection Safety:** Exposed, non-standard cable joints were eliminated. All new connections were enclosed inside rated junction boxes with standardized protective insulators to mitigate short circuits and arc-flash hazards.
- **Fixture Stabilization:** Light fittings previously suspended by temporary materials such as cloth were permanently mounted to ceiling beams.
