Implementation of Water Level Measuring Instruments as Flood Indicator in the Rice Fields of Teluklada Village

CERI AHENDYARTI¹, ADI NUGRAHA¹, IMAMUL MUTTAKIN¹, AHMAD SHULHANY²

¹Electrical Engineering Department, Universitas Sultan Ageng Tirtayasa

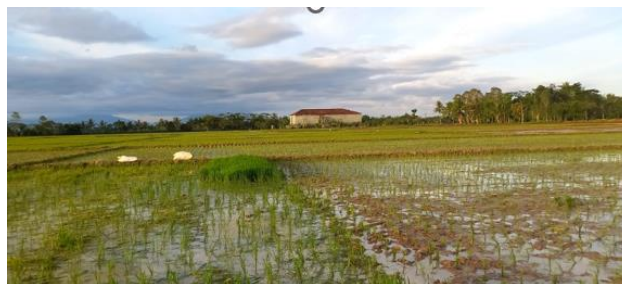
Figure 1. Overview of the distance of rice fields stored by flood notification tools with the

The activities carried out in this land survey are to determine the characteristics of the tool to be designed. In the survey activities were carried out. The survey was conducted on one of the community's lands as shown in figure 1 and carried out various permits. Among them are permits for the use of tools on land, and permits to use land for research so that tools and rice fields remain safe even though in the surrounding area treatment is carried out in the form of land clearance, or land processing to plant rice and water level treatment is maintained in accordance with the research to be carried out.

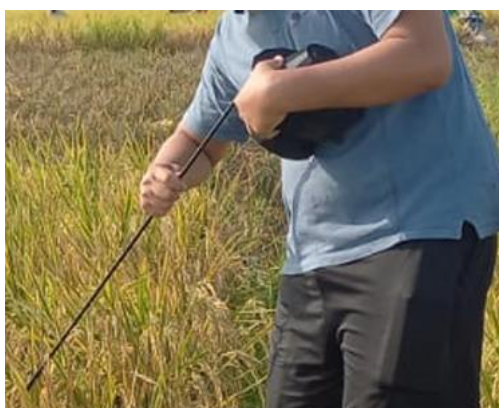
Figure 2. Tool assembly

Before being used in rice fields, the tool is separated in several parts, namely, the tool foot, and also the tool casing. Therefore, before the tool is used, the legs of the tool need to be installed first as shown in figure 2.

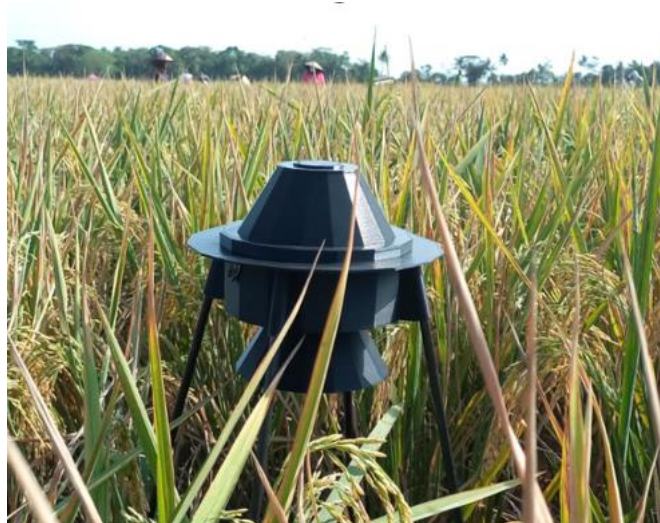
Figure 3. Tools attached to rice fields

The display of the flood detector is shown in figure 3. The detector is installed in the middle of the rice plant. However, the tool does not interfere with rice growth. After that, experiments were carried out by activating the tool using telegram social media.

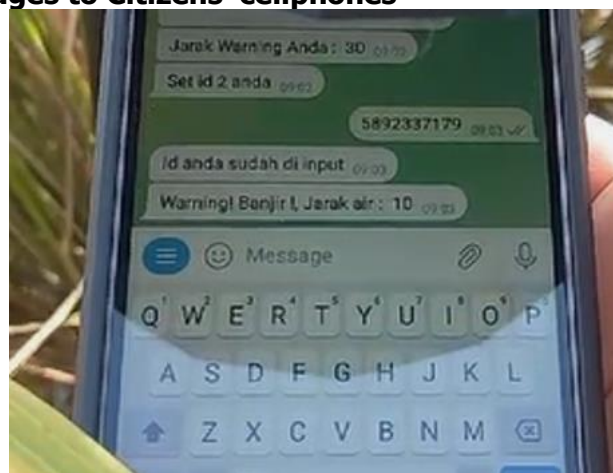
Figure 4. Notifications via telegram

Figure 4 shows the message received by the villagers of teluklada. The message is in the form of a description of a distance of 10 cm. Which in the setting, the distance between the tool and the water level of the rice field is categorized as flooded. Therefore, residents immediately go to the rice fields that have been installed with tools to drain water from the fields.
